COMMONWEALTH OF KENTUCKY
BEFORE THE PUBLIC SERVICE COMMISSION

SOUTH KENTUCKY RURAL ELECTRIC COOPERATIVE CORPORATION)	
)	
)	
_____)	CASE NO. 94-518
)	
ALLEGED VIOLATIONS OF COMMISSION)	
REGULATION 807 KAR 5:041)

APPENDIX TO AN ORDER OF THE KENTUCKY PUBLIC SERVICE
COMMISSION IN CASE NO. 94-518 DATED DECEMBER 21, 1994

ELECTRICAL UTILITY ACCIDENT INVESTIGATION

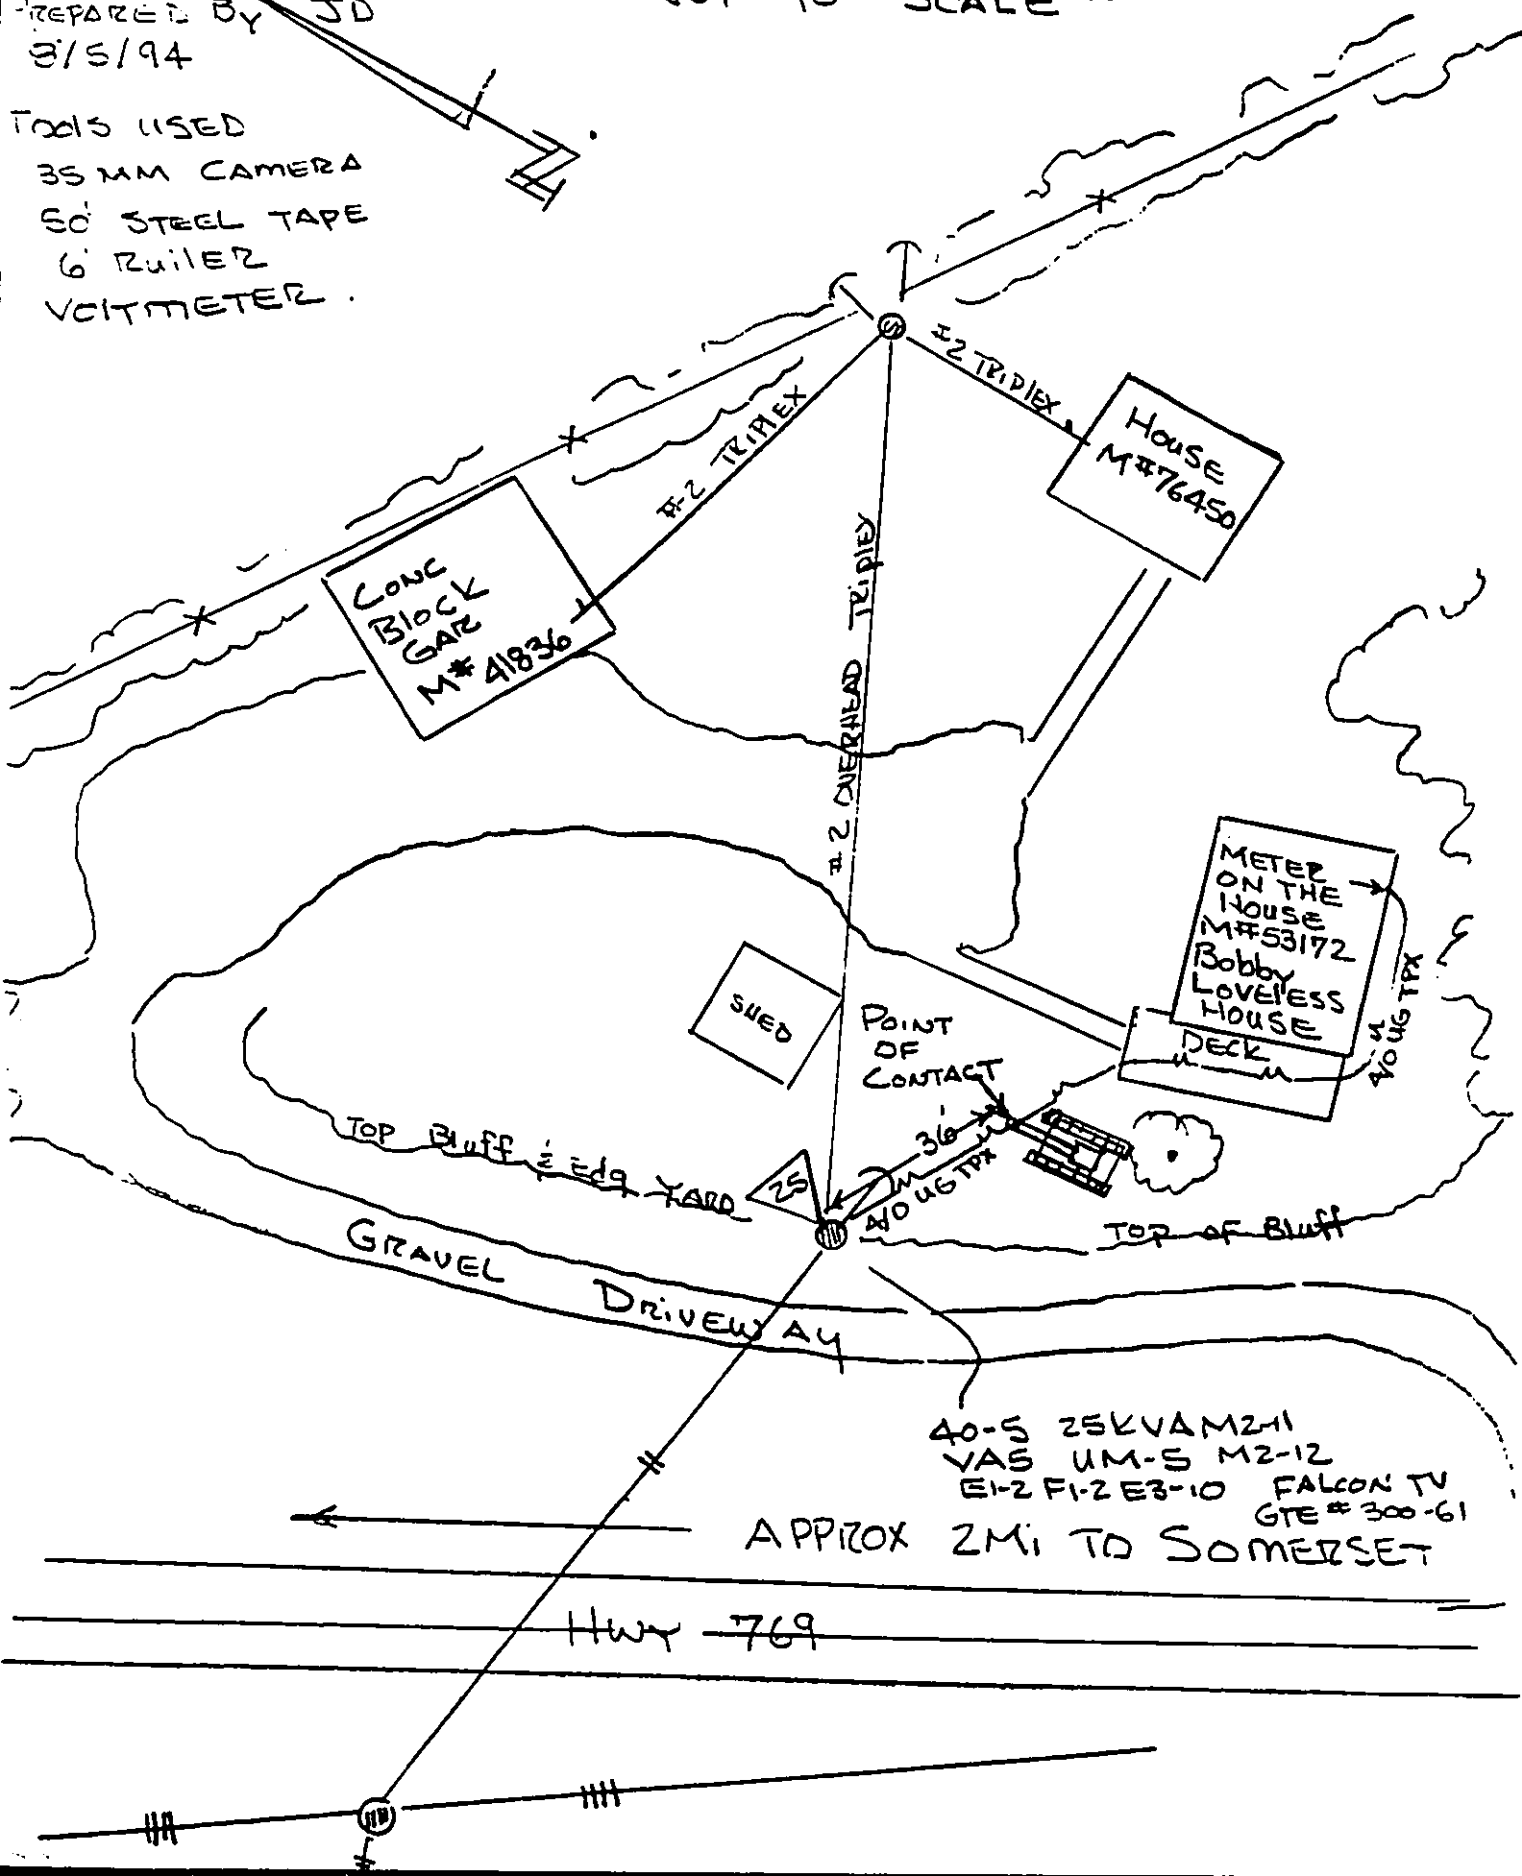
PROBABLE VIOLATIONS There was one probable violation of Commission Regulations involved in this accident. The burial depth of the conductor was 20 inches, resulting in probable violation of 807 KAR 5:041, Section 3(1), Acceptable Standards, which requires compliance with the NESC. The 1990 NESC, Section 353(D2), requires burial depth of underground conductors with less than 600V phase-to-phase to be 24 inches. It should be noted that this violation didn't contribute to the accident.
